Analysis of Lighting Fixtures

MMR Project No. 82999

MassDOT
Boston, MA

April 5, 2011

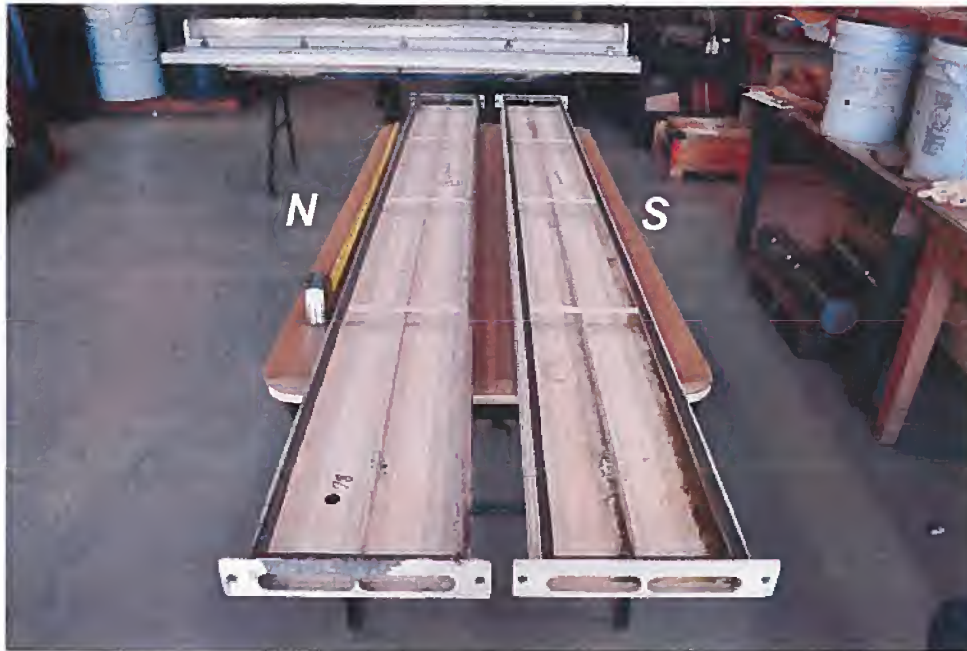
Figure 1: Incident wireway (N) and Schreder comparator (S) as-received with exemplar light assembly in background.

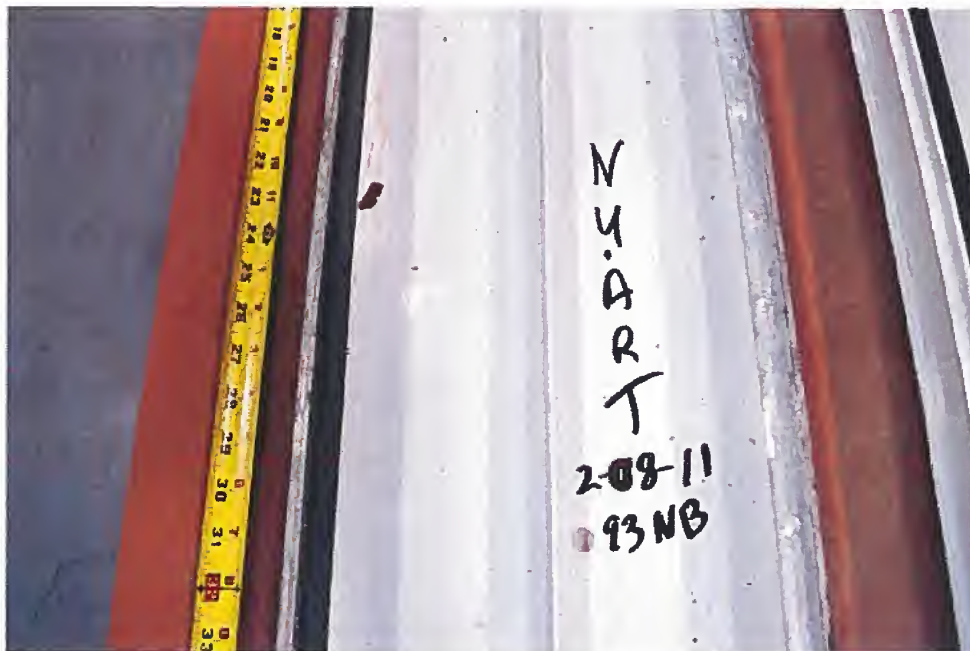
Figure 2: Incident wireway label. Note corrosion and lack of white coating on sides.

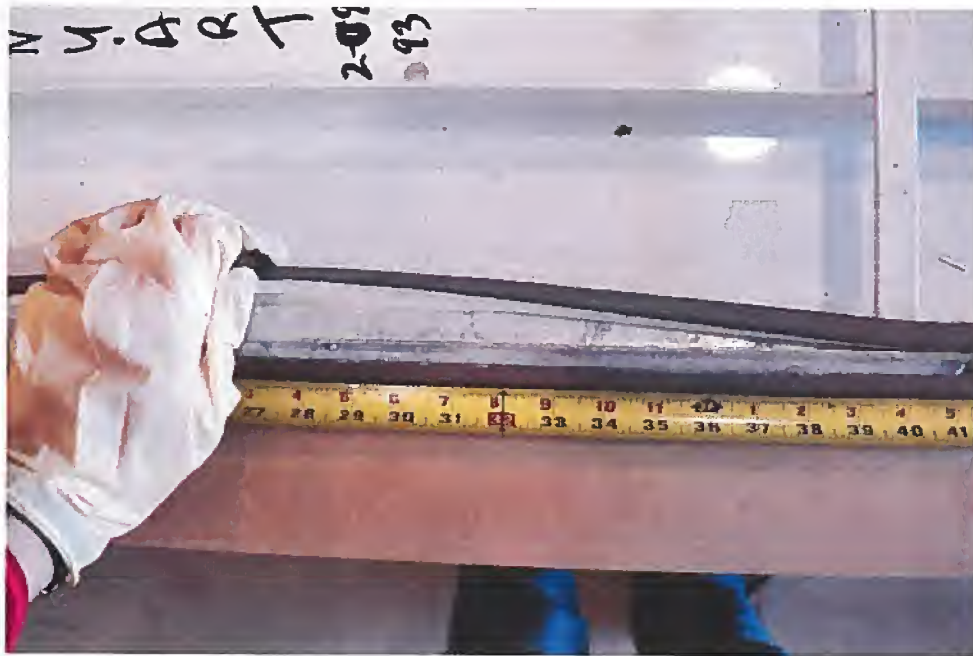
Figure 3: Corrosion was present under the white coating at the gasket.

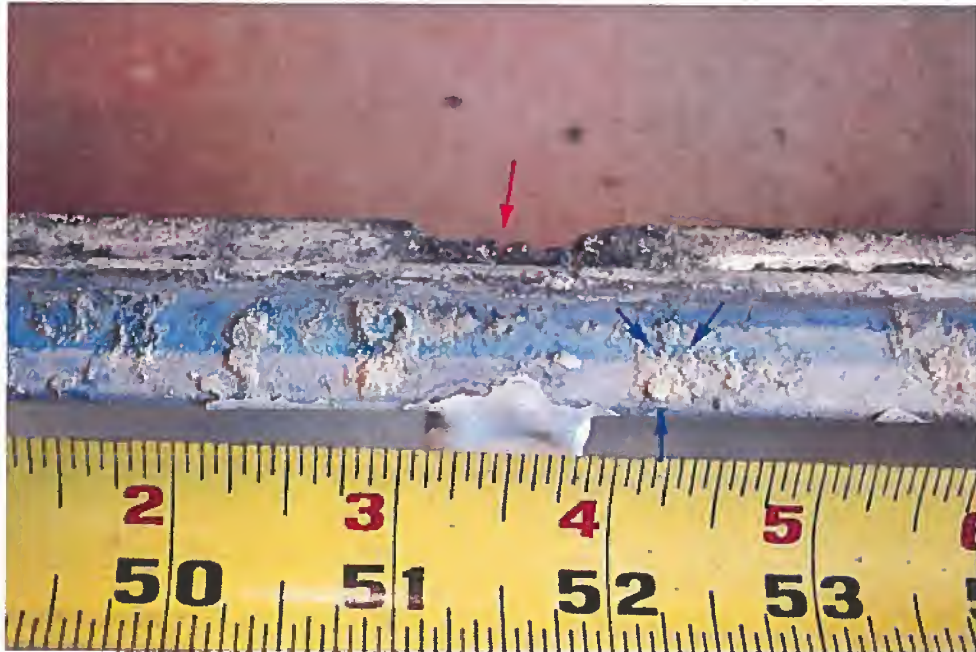
The failed wireway showed complete consumption of material at the lip locations where the clips were attached. All ten locations of the wireway revealed complete consumption of the lip width. This indicated that for this particular fixture, corrosion of the lip areas, where the clips were attached, initiated and propagated at about the same rate. The light fixture disengaged or fell apart from the wireway when the material at the mentioned locations was consumed.

Figure 4: Wasted wireway metal at a former clip location, red arrow. Corrosion debris, blue arrows, was present wherever coating could be removed.

We suggest removing the retention clips from the present locations to other areas of the lip where only surface corrosion is noted. Even in the absence of the powder coat, it should take about 3 to 4 years for the wireway lip thickness to be completely consumed based on the corrosion noted at the engagement locations of the failed wireway. Note that the subject failed wireway was in service for about 8 years. This assumption should be valid if the light fixtures experience the same environmental conditions as the failed one.

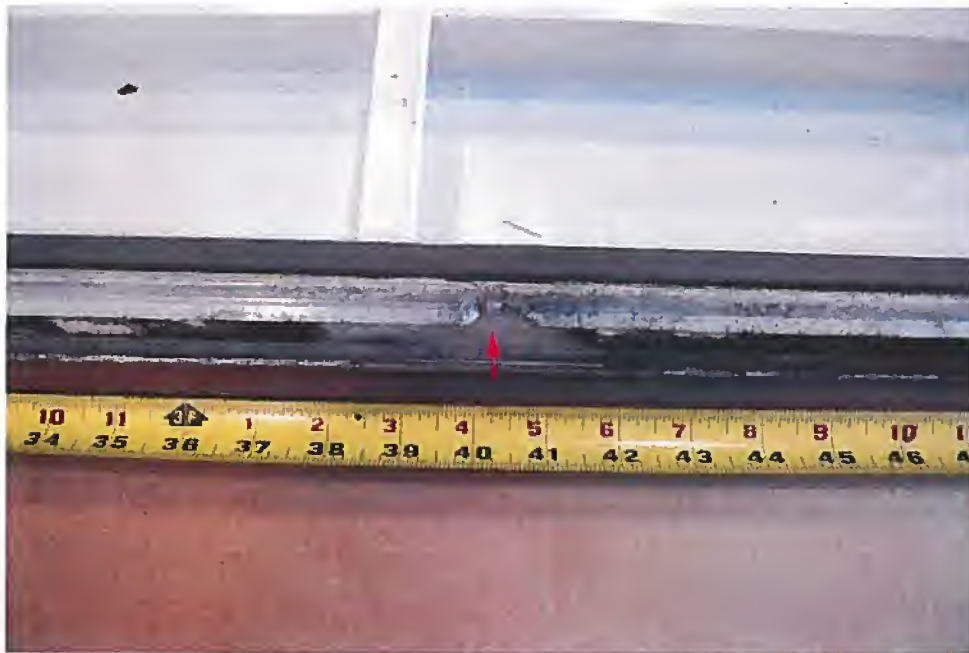
Figure 5: Another clip location, arrow.

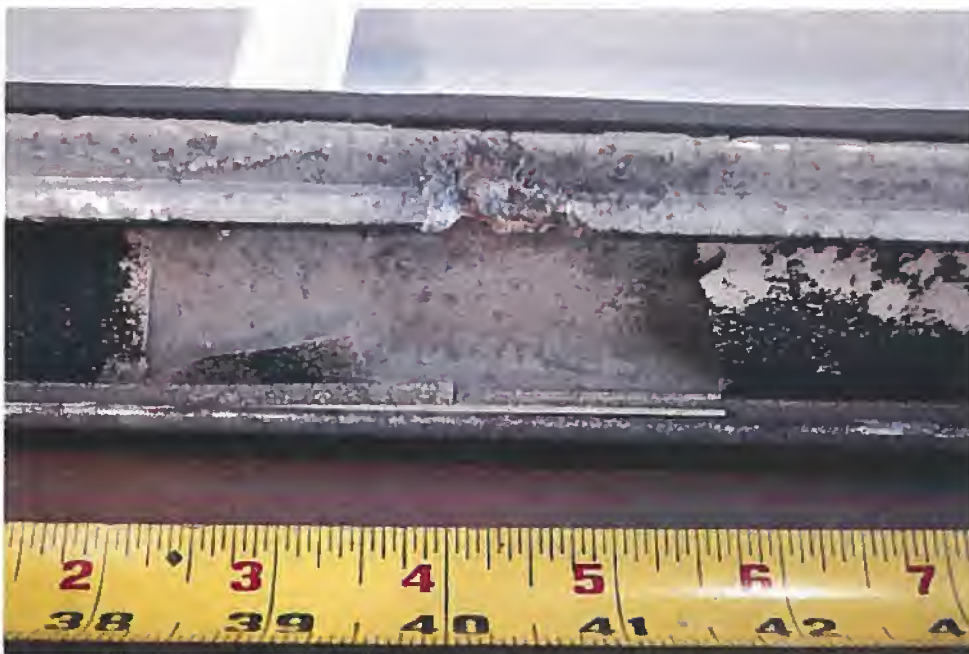
Figure 6: Detail of Figure 5 clip location. Also note soot-blackened paint surface on side rails.

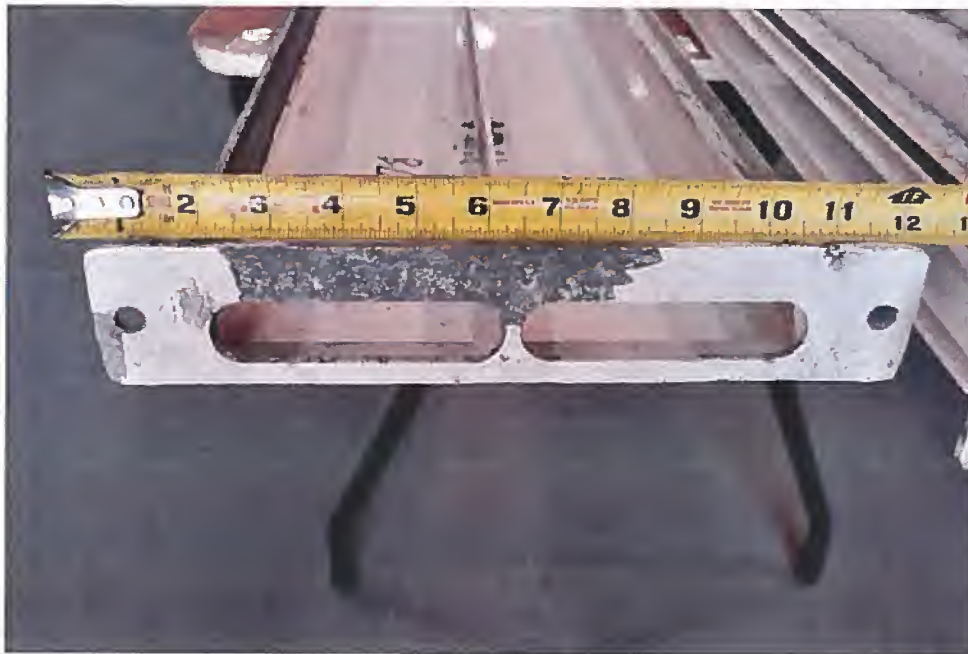
Figure 7: Incident wireway end cap, overall.

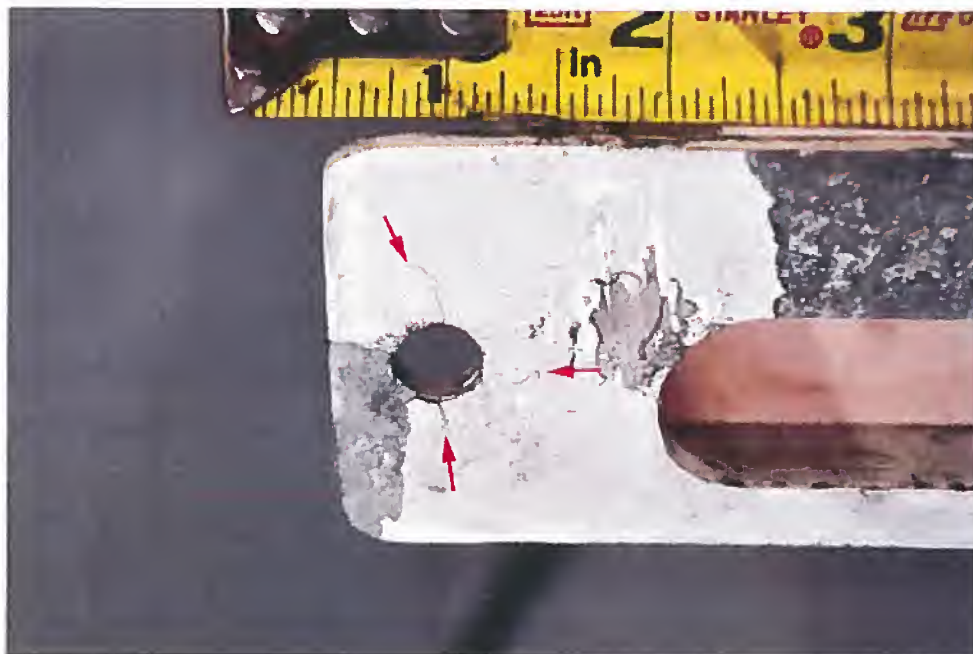
Figure 8: Incident wireway end cap at screw hole; note paint cracks emanating from hole, arrows, and lack of paint in hole.

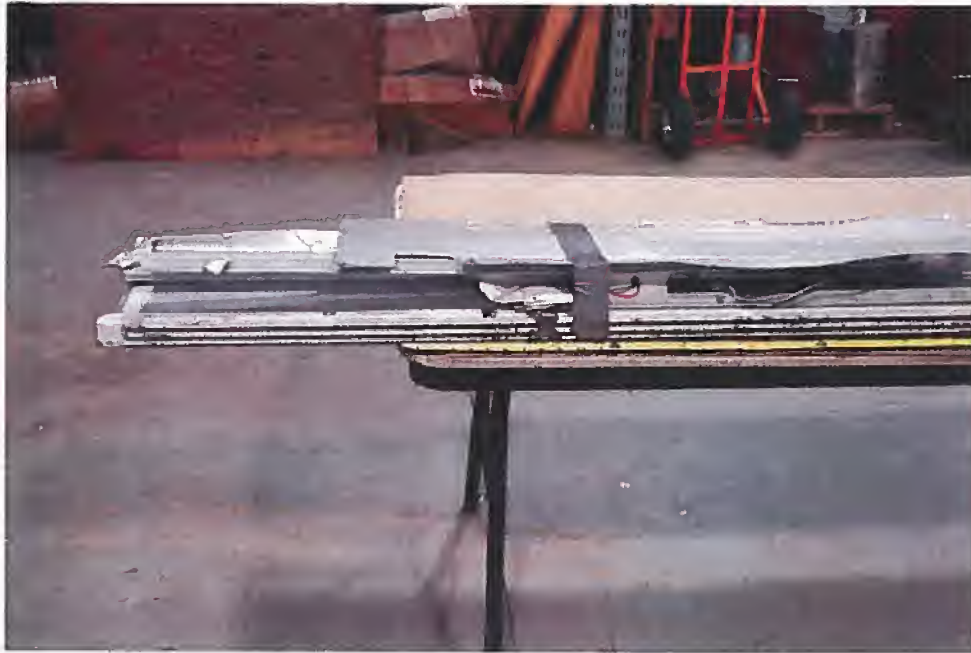
Figure 9: Base from light that fell onto the roadway, one side, as-received.

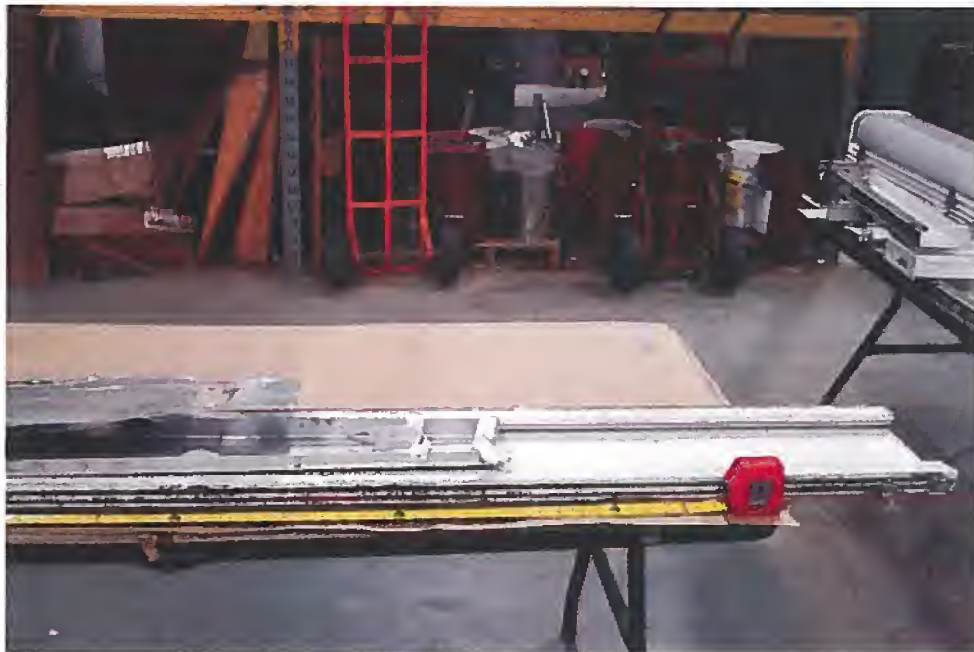
Figure 10: Base from light that fell onto the roadway, other side, as-received.

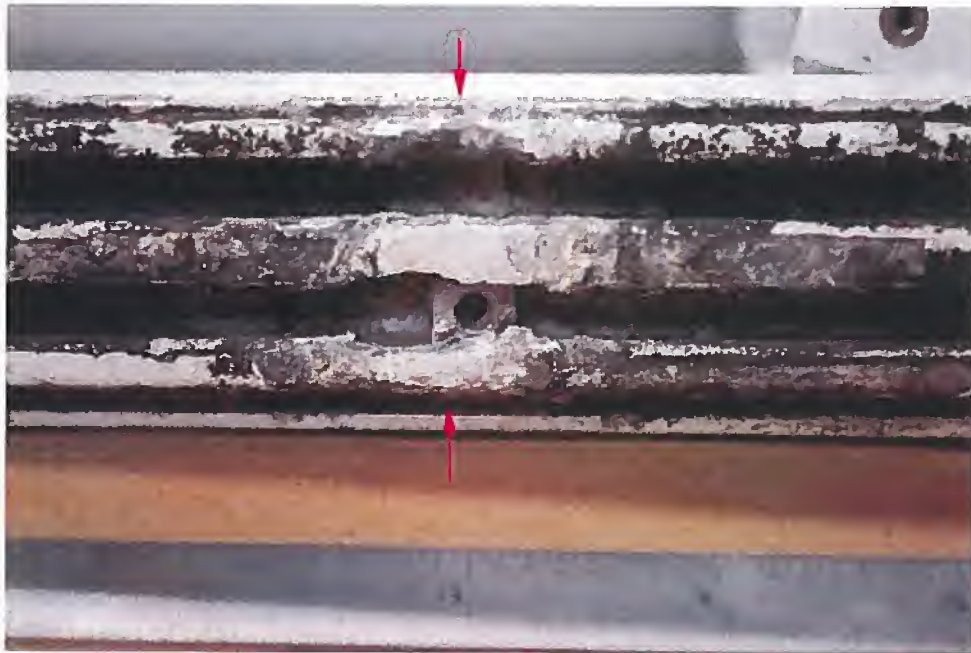
The base of the light fixture which was attached to the wireway revealed corrosion at the locations where the clips were screwed on. However, the corrosion did not appear to be as significant as the wireway engagement locations. Away from the screwed on clip locations, peeling off of the coating was noted from the substrate with whitish/yellowish debris on the aluminum substrate. The areas away from the clips did not reveal any evidence of significant corrosion of the aluminum base.

Figure 11: Clip locations on the incident light base also exhibited metal wastage, arrows.

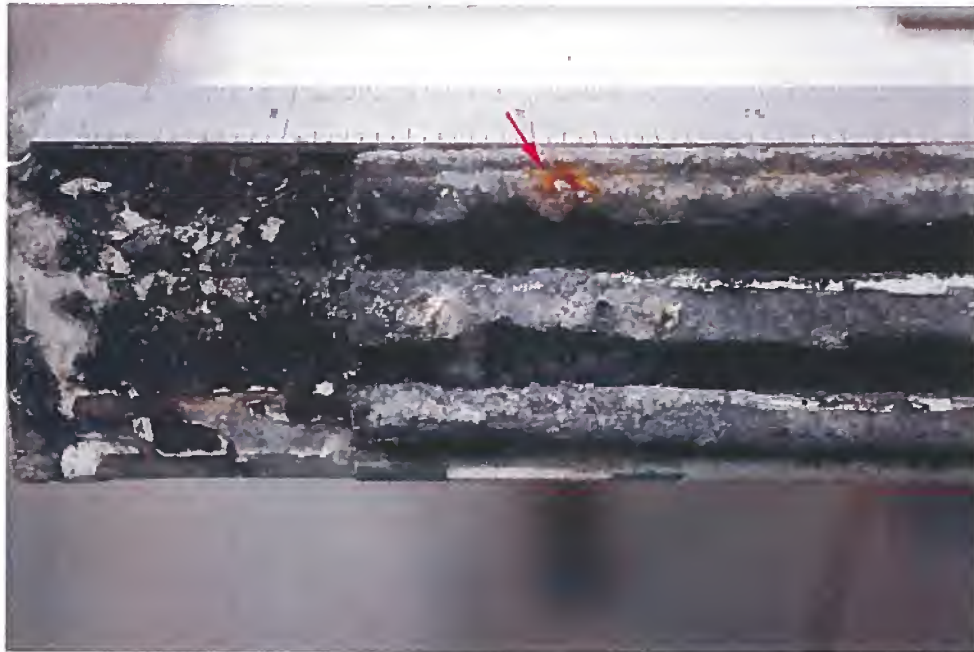
The clip we have examined did not show any corrosion. However, we have noticed some rust colored deposit on the failed large fixture base. This would indicate that some of the clips may have shown some corrosion. It is not the requirement in a crevice corrosion situation that the 300 series SS clips will have to corrode. It may or may not show evidence of corrosion depending on whether it is anodic or cathodic to its mated material.

Figure 12: Isolated rust-colored regions were present at clip locations on the incident light base, arrow, but they were rare.

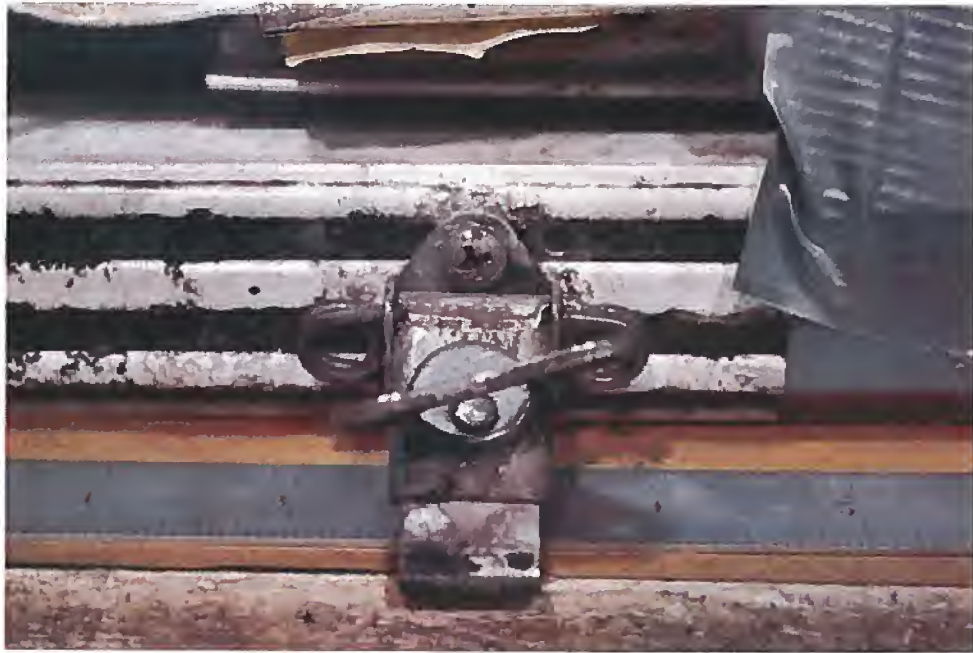
Figure 13: A typical clip from the incident base.

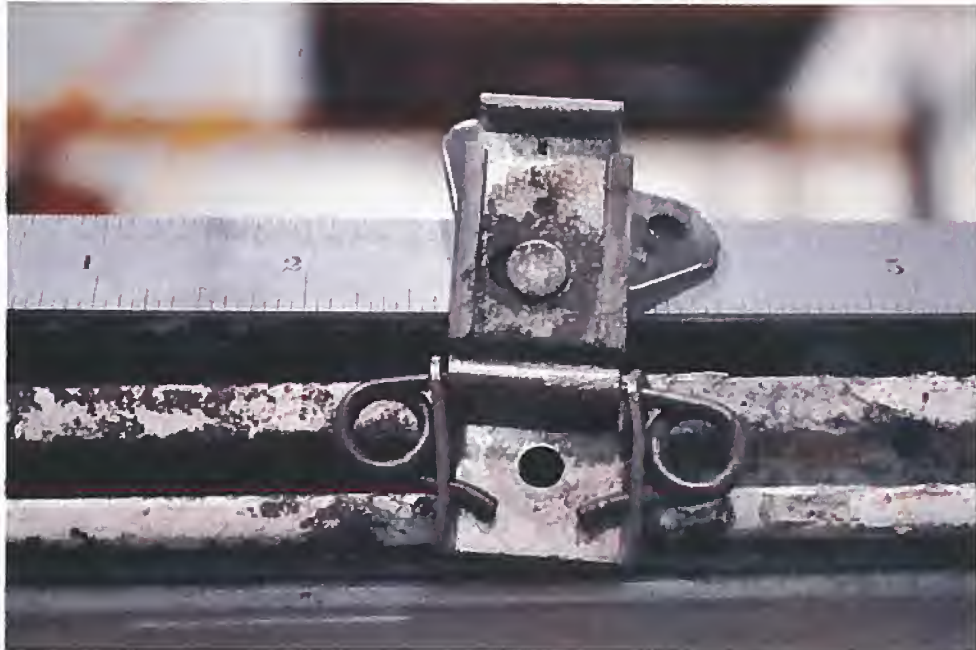
Figure 14: Typical clip underside from the incident base.

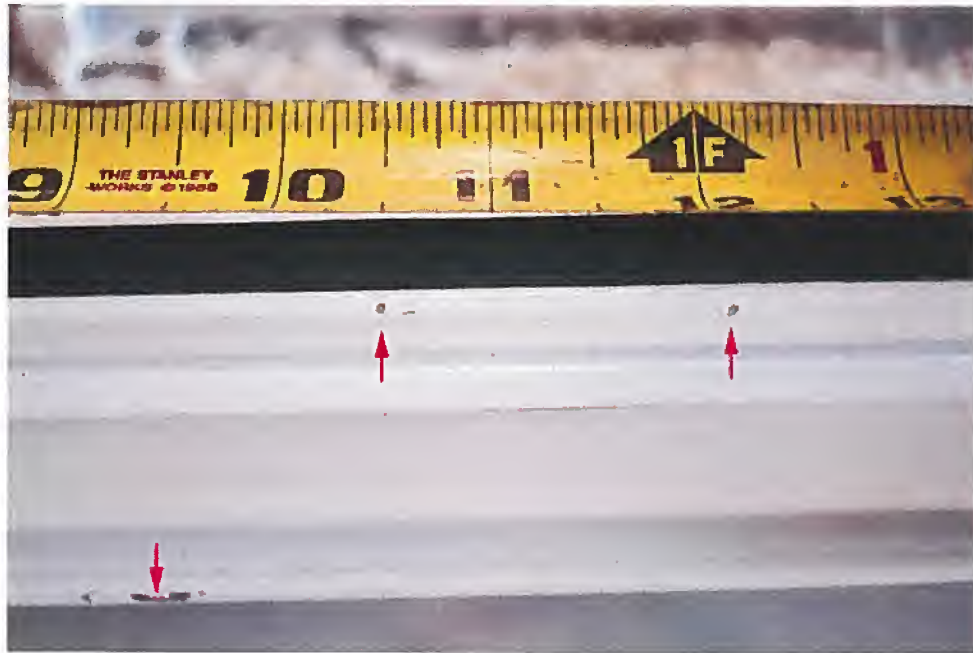
Figure 15: Unused Schreder wireway handling damage to white coating, as-received, arrows.

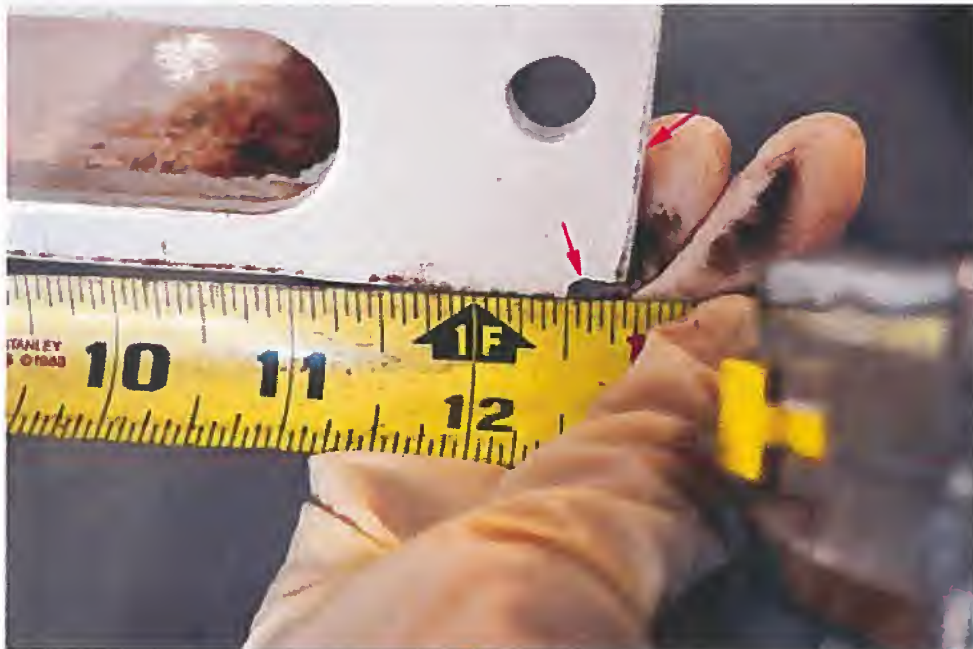
Figure 16: The end caps and most edges of the unused Schreder wireway exhibited mechanical damage to the coating, arrows.

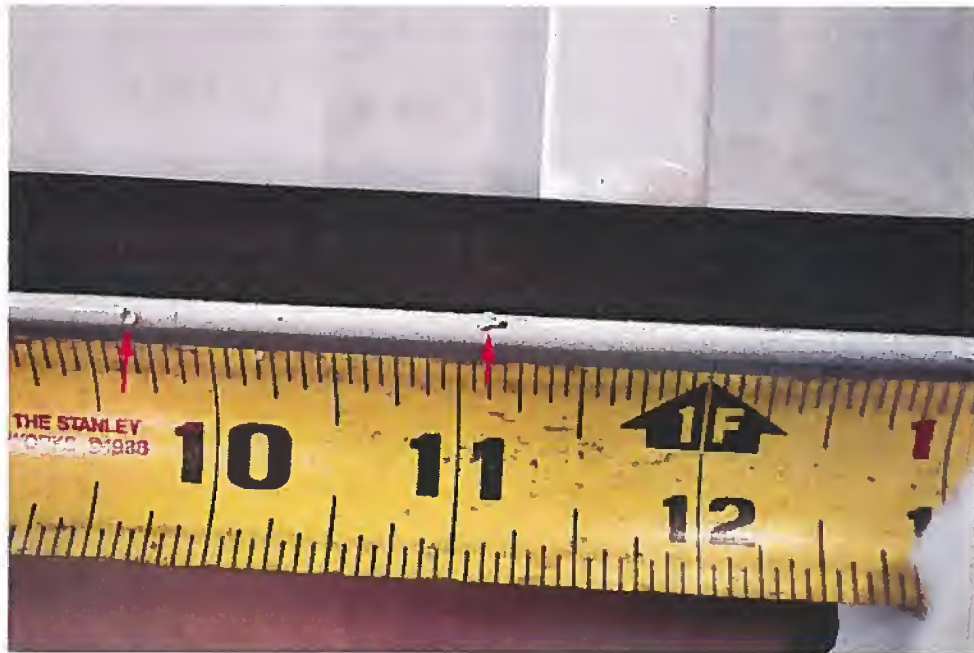
Figure 17: Typical edge damage to coating on both unused wireways, arrows.

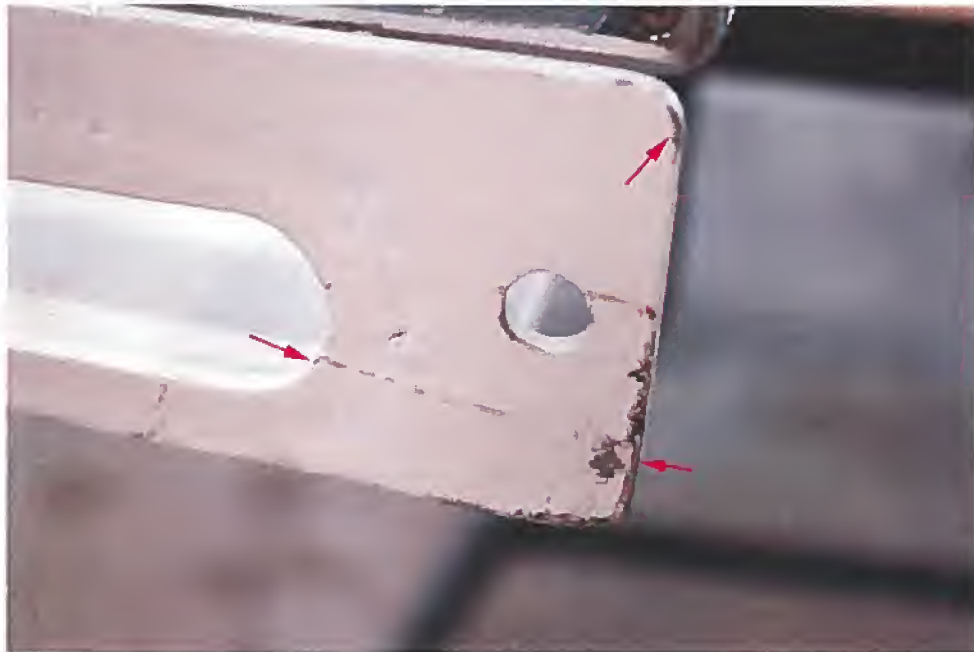
Figure 18: The unused NuArt wireway exhibited mechanical damage similar to the Schreader, arrows.

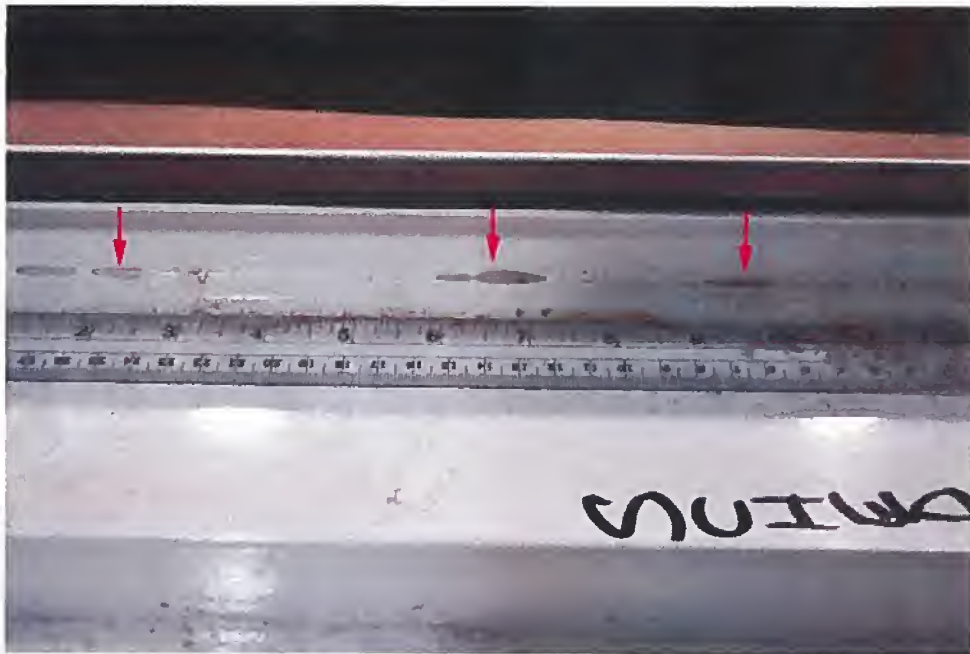
Figure 19: The unused Schreader wireway possessed large gaps in its coating at an interior recess, arrows.

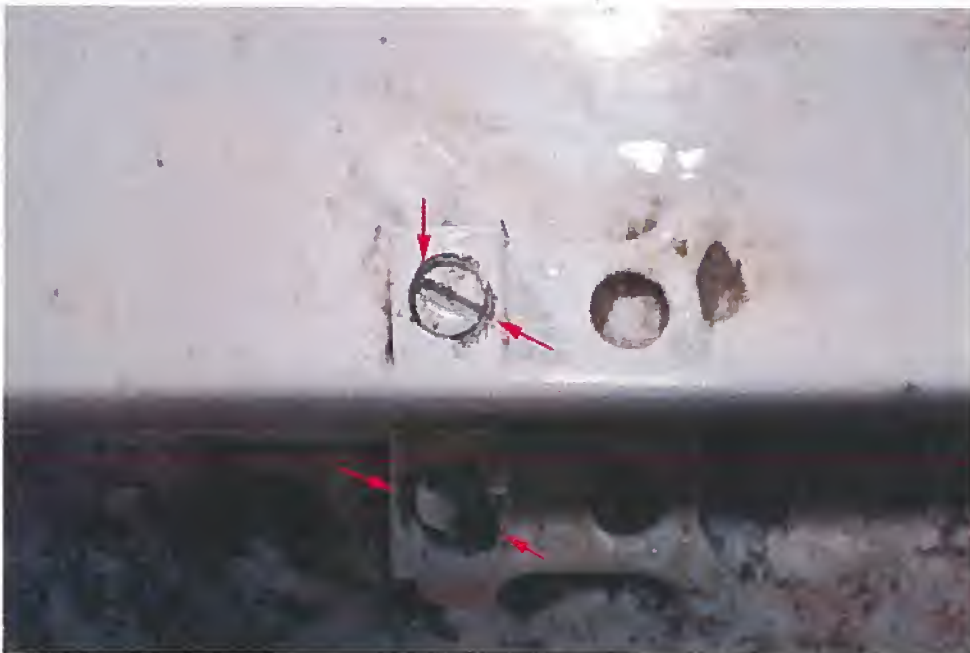
displayed absence of coating from the coating application process. Breaching of coating was noted at the screwed on grounding lug locations. This condition indicates that during the screw installation operation the coating can be breached easily.

Figure 20: Unused Schreader wireway: grounding lug at an interior surface. Note the breached coating, arrows, during installation of the screws.

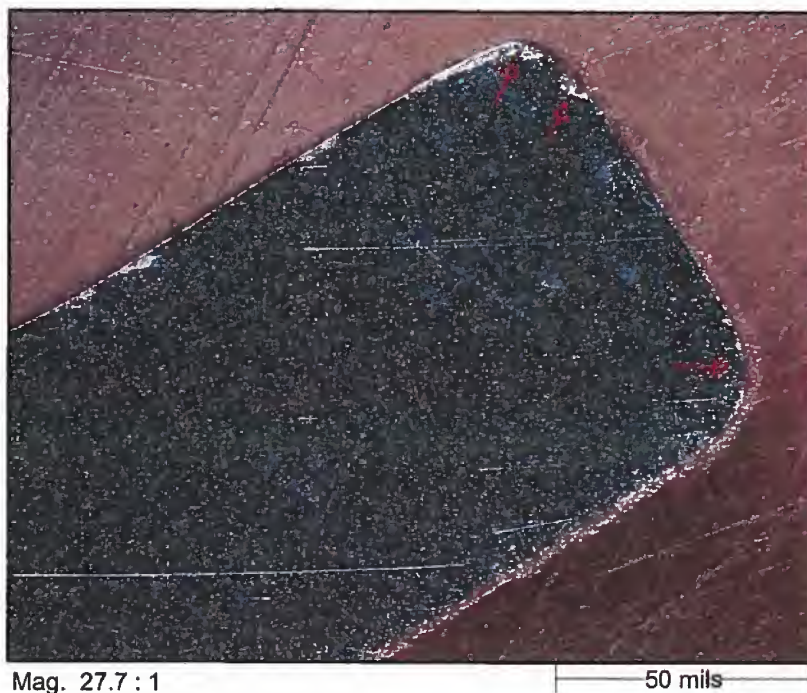
Figure 28: Sample #1: Mount 1-3. Lip area. Arrows point to areas with evidence of corrosion.

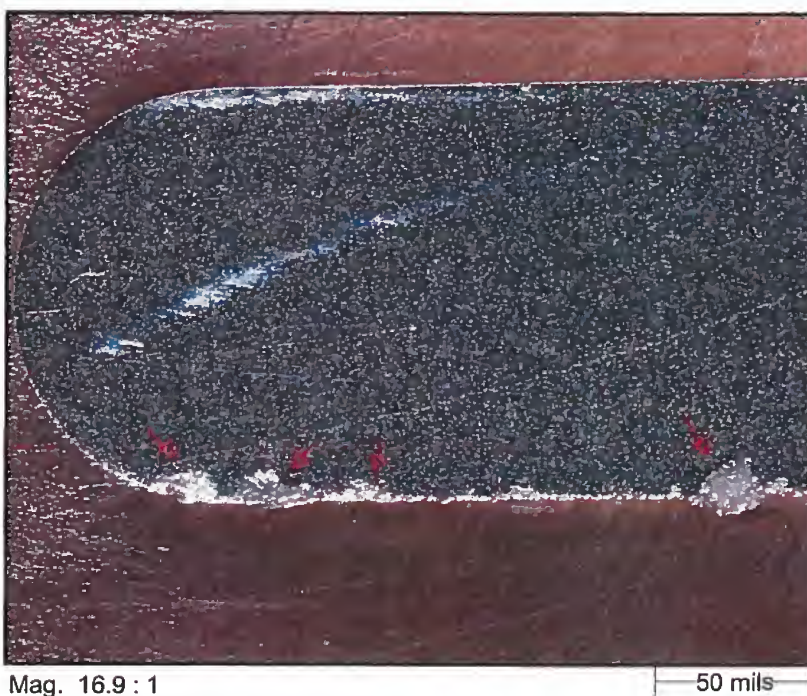
Figure 29: Sample #1: Mount 1-3. Tab opposite to the lip. Arrows point to areas with evidence of corrosion.

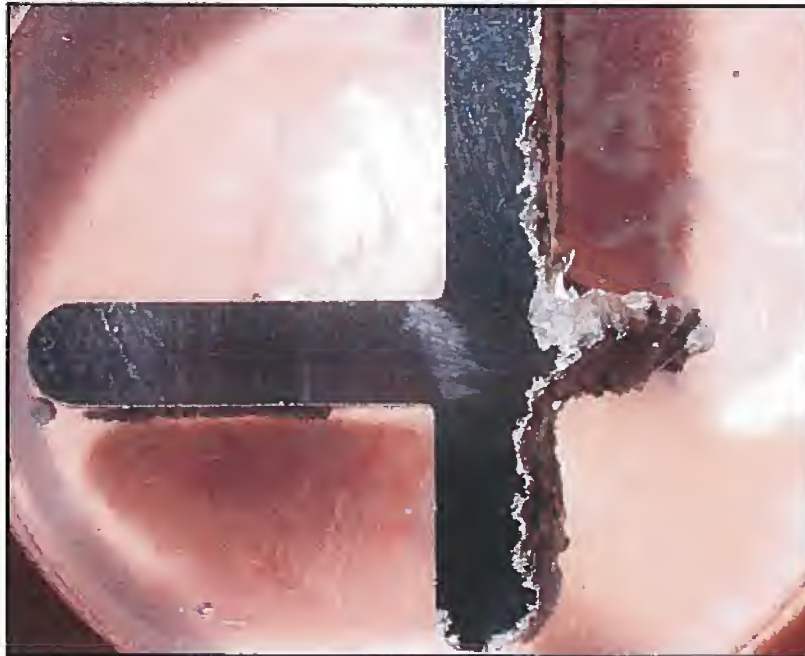
Examination of the mounts revealed significant corrosion of the wireway at the locations where the light fixture was attached to the 300-series stainless steel (SS) clips. The complete thickness of the wireway lip was consumed at these engagement locations resulting in separation of the light fixture from the wireway. Corrosion was also noted on areas adjacent to the failed lip location, but to a lesser degree.

Figure 30: Sample #1: Mount 1-1. This mount is through the wasted area where the clip was attached to the lip. Note completely consumed lip area with severe corrosion on adjacent surfaces.

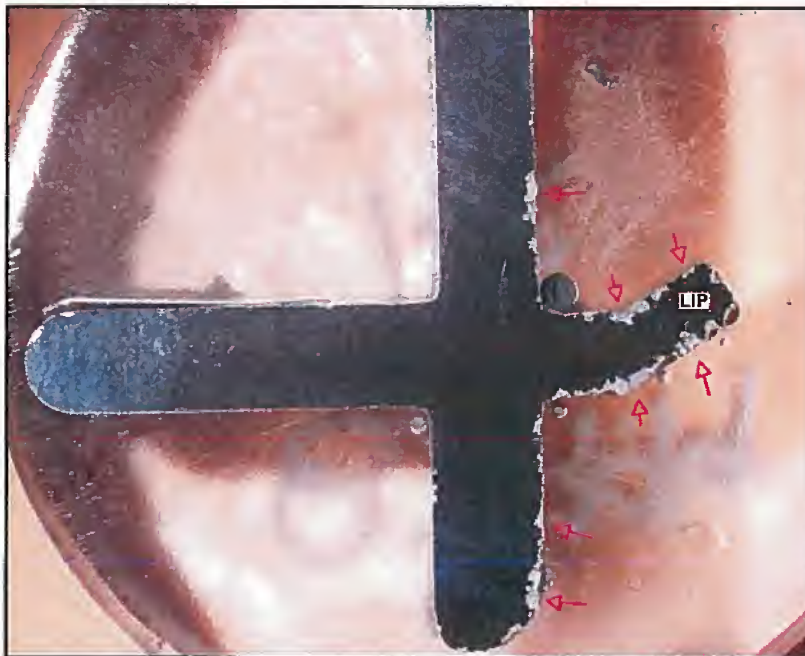
Figure 31: Sample #1: Mount 1-2. This area is next to the consumed lip location. Arrows point to corroded areas.

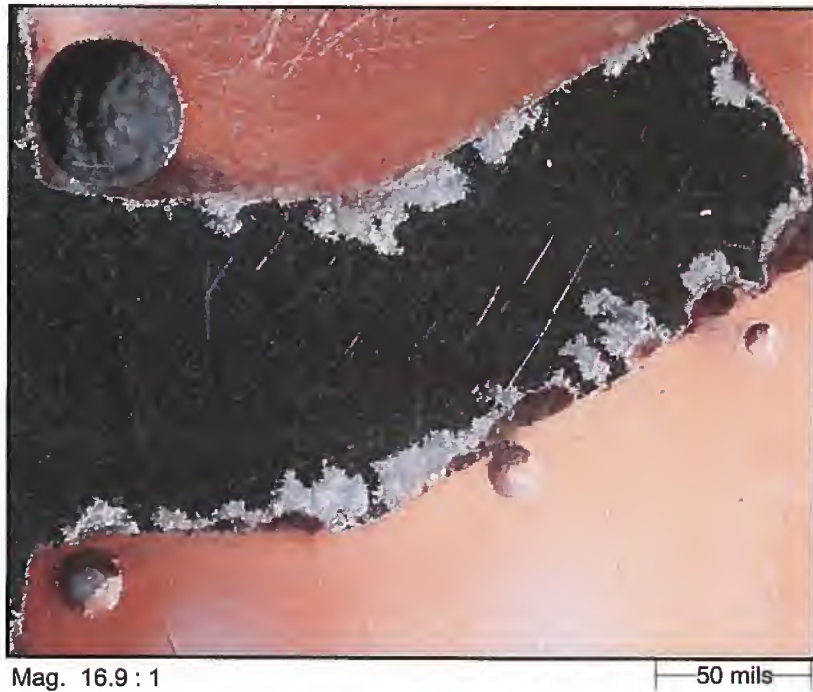
Figure 32: Sample #1: Mount 1-2. A higher magnification view of the lip location with corrosion.

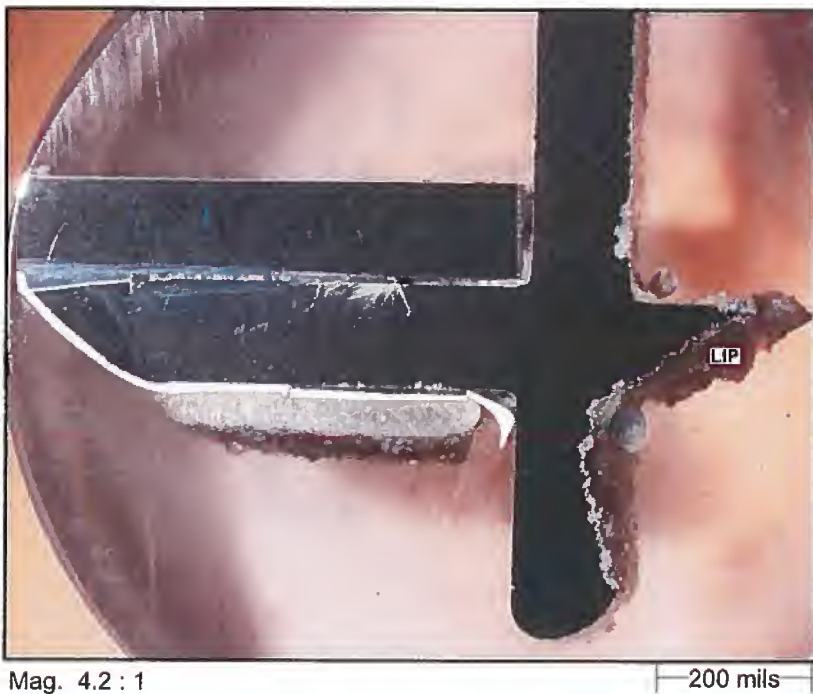
Figure 33: Sample #1: Mount 1-4. This mount is through another wasted area where the clip was attached to the lip. Note completely consumed lip area with severe corrosion on adjacent surfaces.

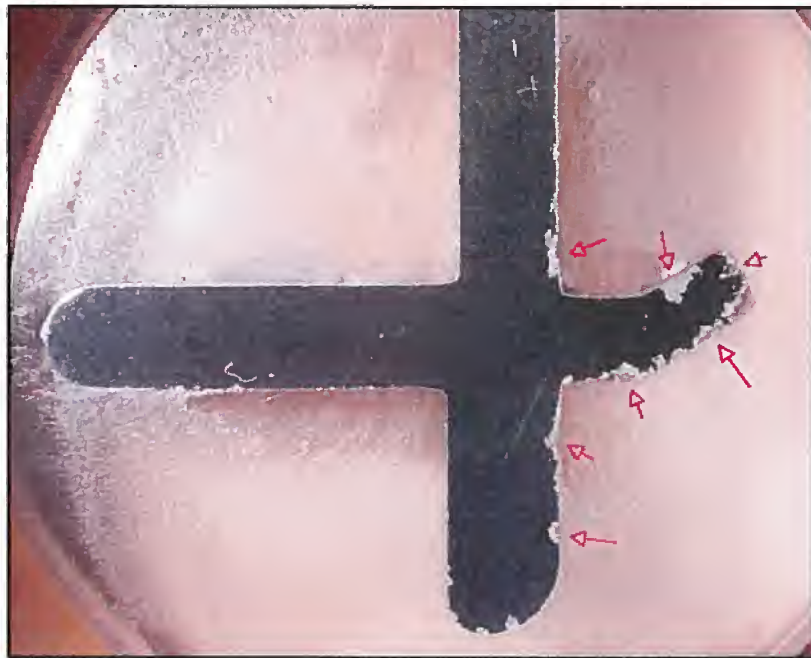
Figure 34: Sample #1: Mount 1-5. This area is next to the consumed lip location in mount 1-4. Arrows point to corroded areas.

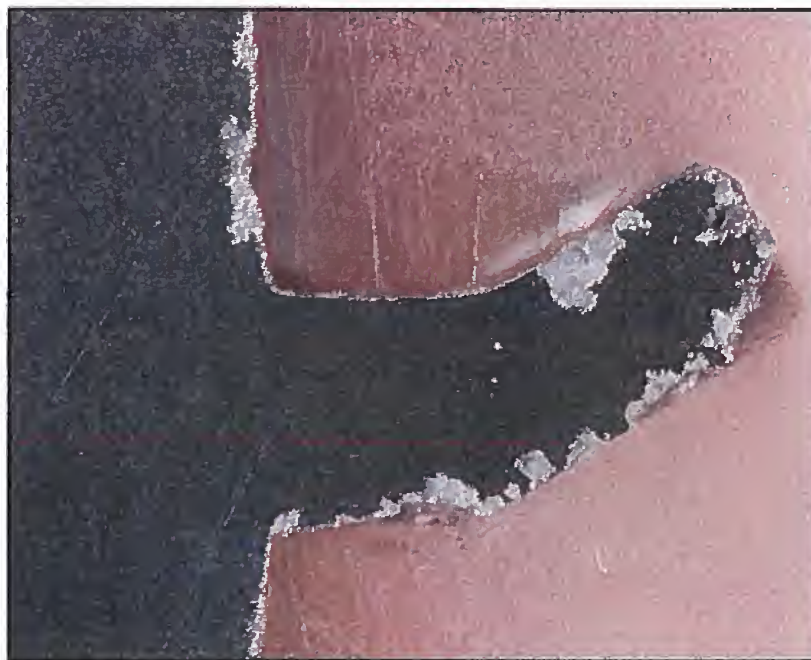
Figure 35: Sample #1: Mount 1-5. A higher magnification view of the lip location with corrosion.

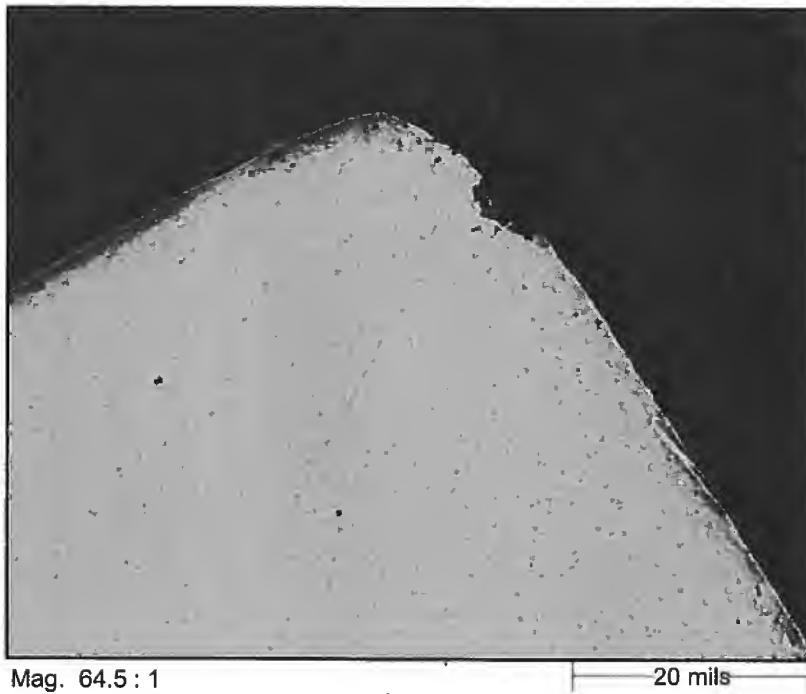
Figure 36: Sample #1:Mount 1-3; lip edge. Note some corrosion. Unetched.

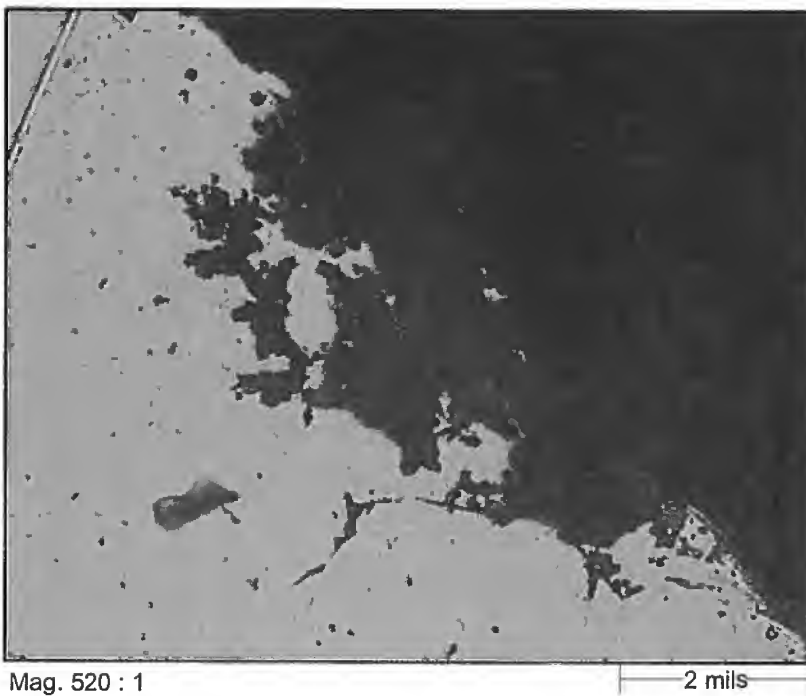
Figure 37: Sample #1:Mount 1-3; lip edge. A higher magnification view. Note some corrosion. Unetched.

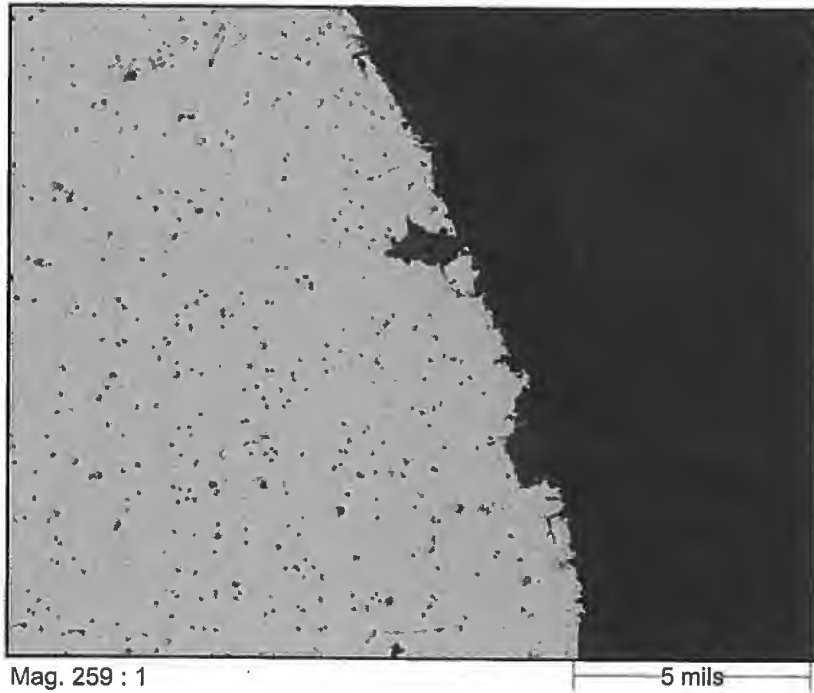
Figure 38: Sample #1:Mount 1-3; the other lip edge. Note shallow corrosion. Unetched.

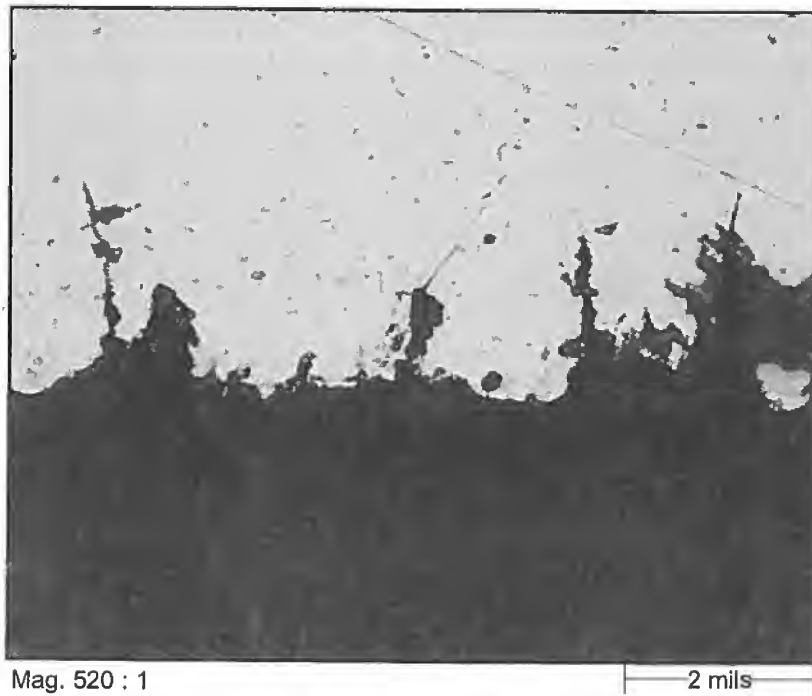
Figure 39: Sample #1:Mount 1-3; the tab area opposite to the lip area. Note some corrosion.

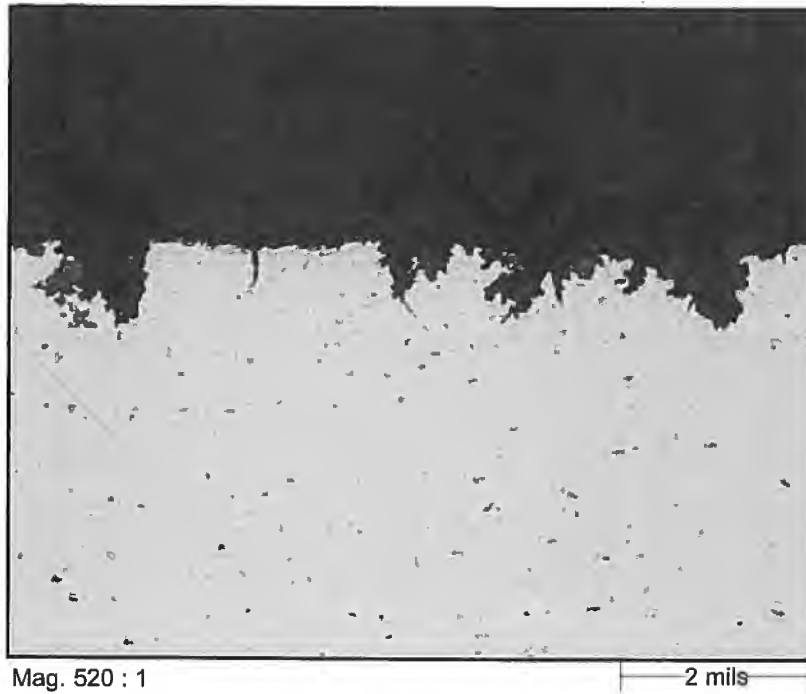
The cross-section away from the severely corroded areas showed initiation of corrosion in an intergranular mode, which progressed to a more pitting type general corrosion. Note that corrosion to a significant depth was not noted for the areas away from the engagement locations.

Figure 40: Sample #1: Mount 1-3; the tab area opposite to the lip area. Note initiation of corrosion in an intergranular mode progressing to pitting type. Unetched.

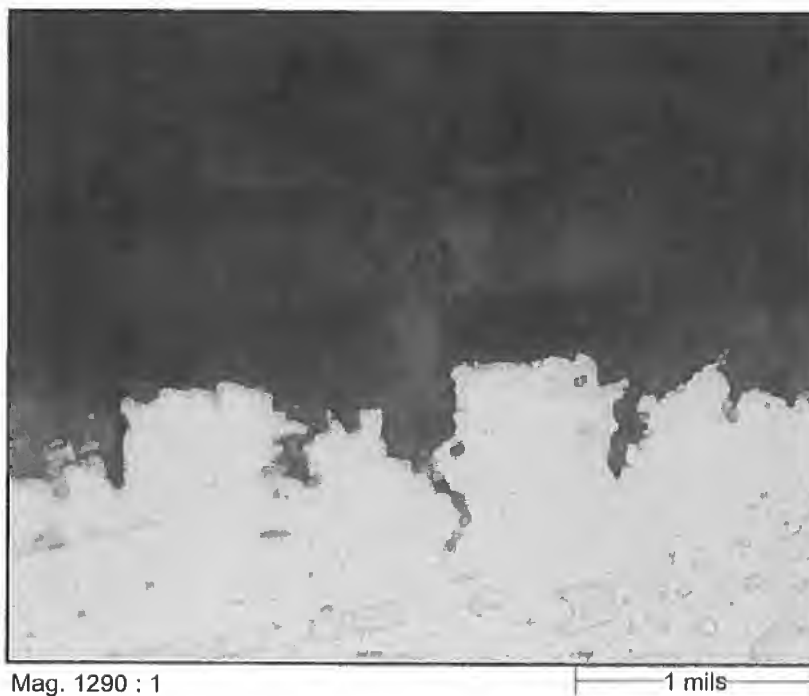
Figure 41: Sample #1: Mount 1-3; lip radius showing corrosion initiation.

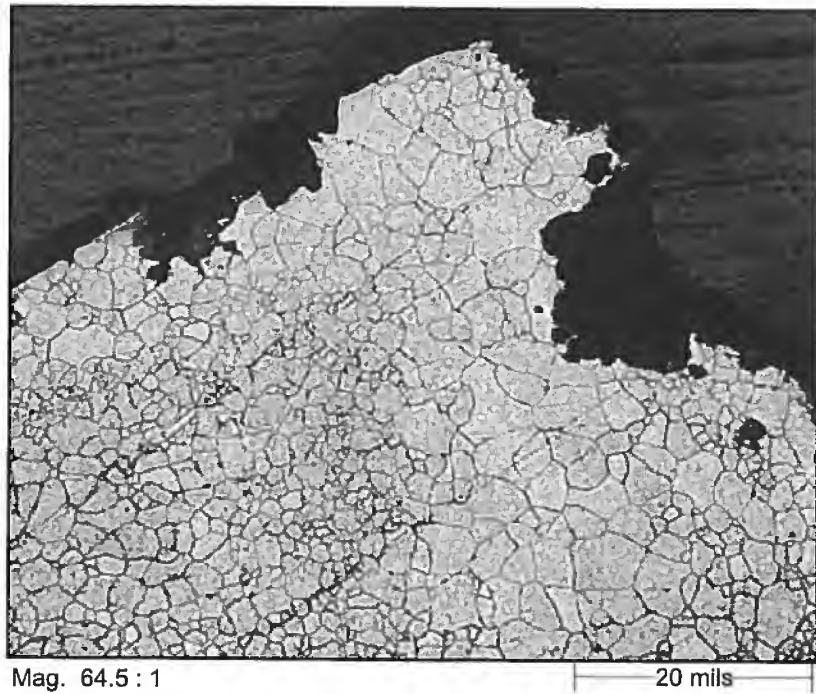
Figure 42: Sample #1: Mount 1-2; note significant corrosion on the lip. Etched.
